The Conservator's Point of View

Condition of the panel and toolmarks

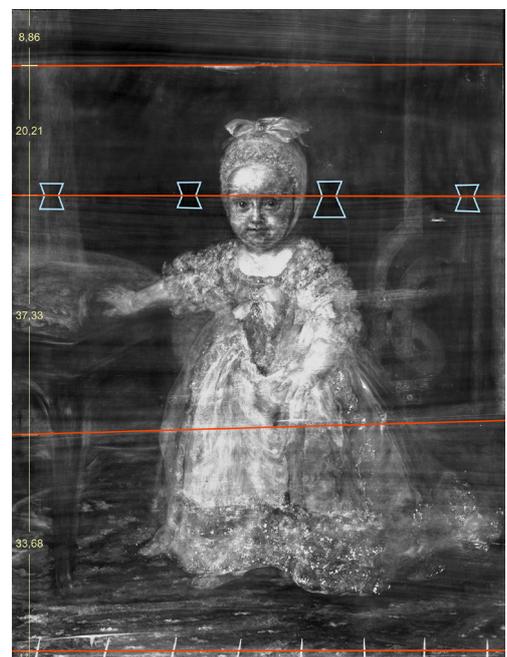
The relatively large and heavy walnut panel consists of four horizontal boards of different widths, which are glued together butt-jointed. All four side edges were provided with a milled 0.7 to 1 cm deep step. On this panel the step at the bottom was probably levelled with a narrow strip stepped in opposite directions before painting – presumably to create a better support surface for the heavy wooden panel (*fig. 1*).¹ Close to this step on the reverse side, three holes have been drilled on both sides, possibly for either the application of a groove bar during the painting process, for a temporary frame or for assembling the panel within wall panelling. Visible drops of the priming and of the paint layer on the side edges show that the format of the panel and its milled edges are original features (*figs. 2a, b, c*). A light brown matt and coarse-grained protective coating has been applied to the reverse of the panel. This coating is original. In raking light marks of planning and tool marks become apparent (*fig. 3*). In general, the panel is in good and stable condition, the joints are slightly open in some places. Between the second and third board, the joint which was re-glued in an earlier intervention has been connected with four dovetails. The glued joint at the bottom edge was also reinforced with eight nails at a later date (cf. *fig. 1*).

Fig. 1
X-radiograph; mapping of joints with tool marks, alterations and damages. The x-radiograph shows the distribution of paint layers containing lead white. It conveys information about the construction and the quality of the panel as well as the condition of the original paint layer.

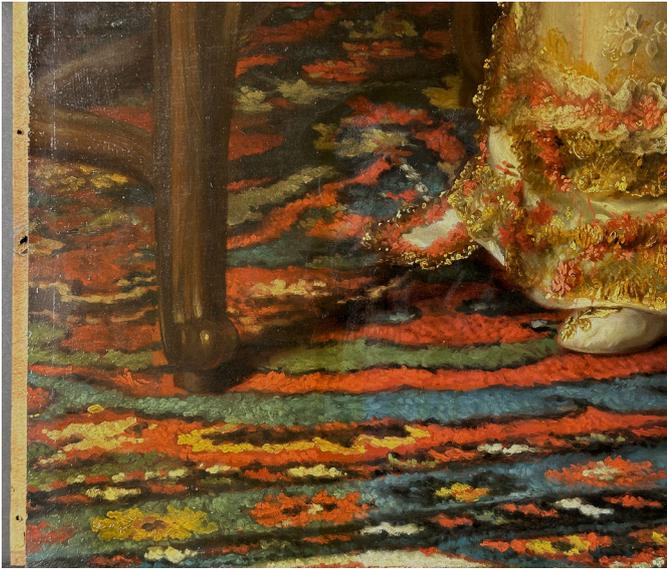
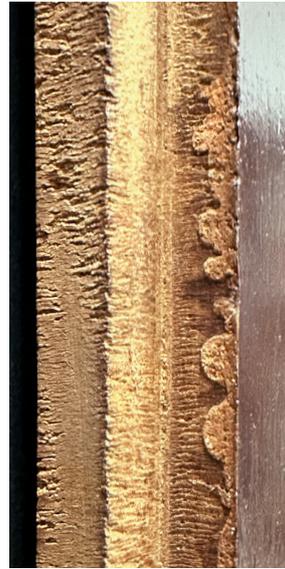
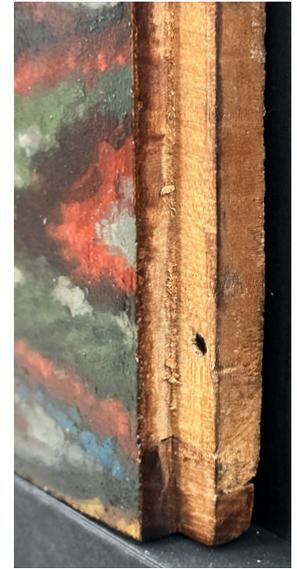
Figs. 2a, b, c

fine-grained surface. By contrast to the meticulous rendering of face and white lace, the dress is painted in a free manner with less detail. Especially impressive is the rendering of the colourful carpet which shows variegated brush work with highly nuanced colouring (cf. *fig. 2a*).

Details during restoration; the original step is visible on the left edge. The yellowed varnish causes the green appearance of the blue colour of the carpet (left image). Left edge with drops of original priming and right edge showing original stepping (image in the middle). The step at the base was equalised with an additional bar before the priming was applied (right image).

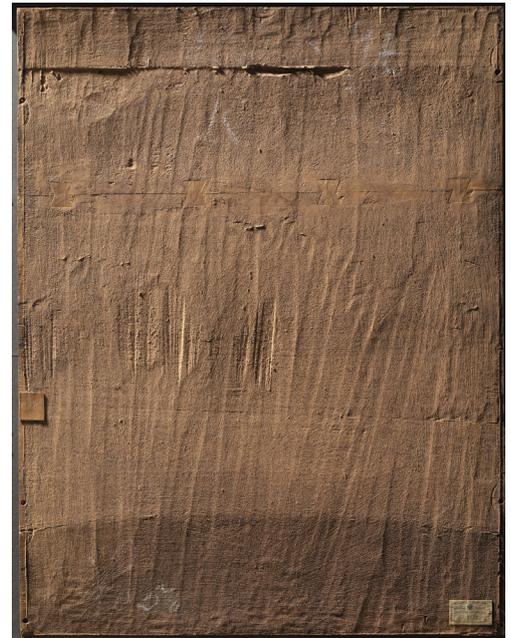
Fig. 3
Reverse with original coating in raking light.

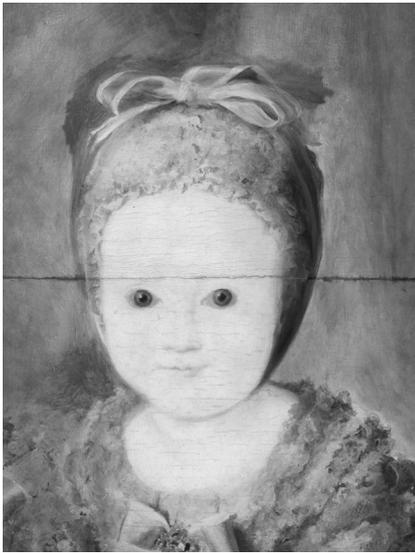
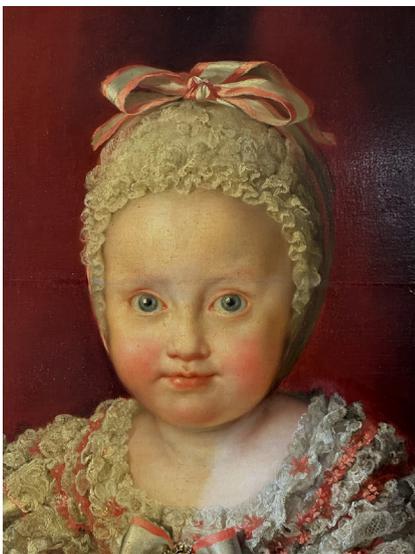
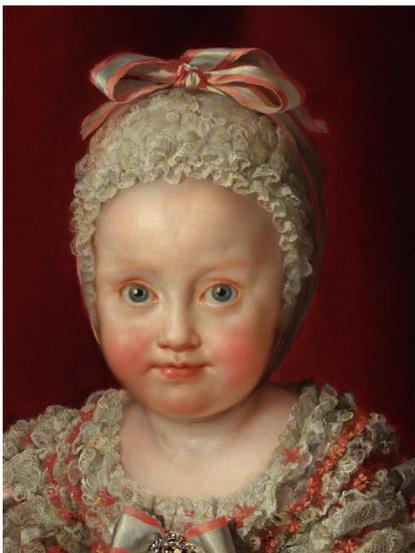
A bright chalk primer forms the basis of the oil-bound paint layer. A few fine underdrawing lines are only visible on the face and hands (*figs. 4a, b, c*). The application of the paint layer varies according to the forms and is relatively impasto in light areas worked with lead white, for example the dress, the embroidery or the brooch (*figs. 5a, b*). Some individual areas are painted wet in wet. In addition to the impasto areas, especially the background shows a smooth flatly applied paint layer with a

Figs. 4a, b, c
Detail of the head in infrared-reflectography, during restoration, and in visible light after restoration.

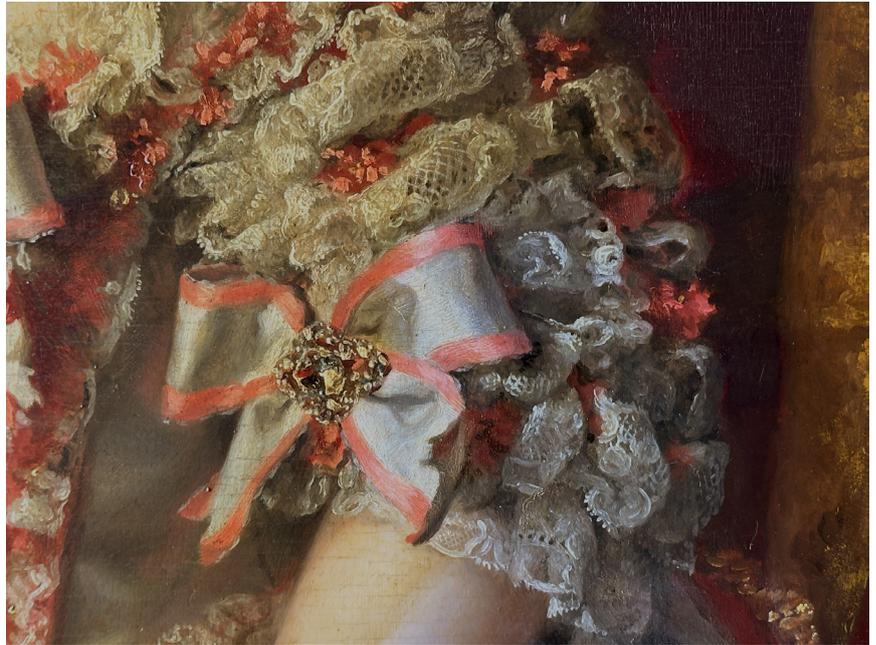
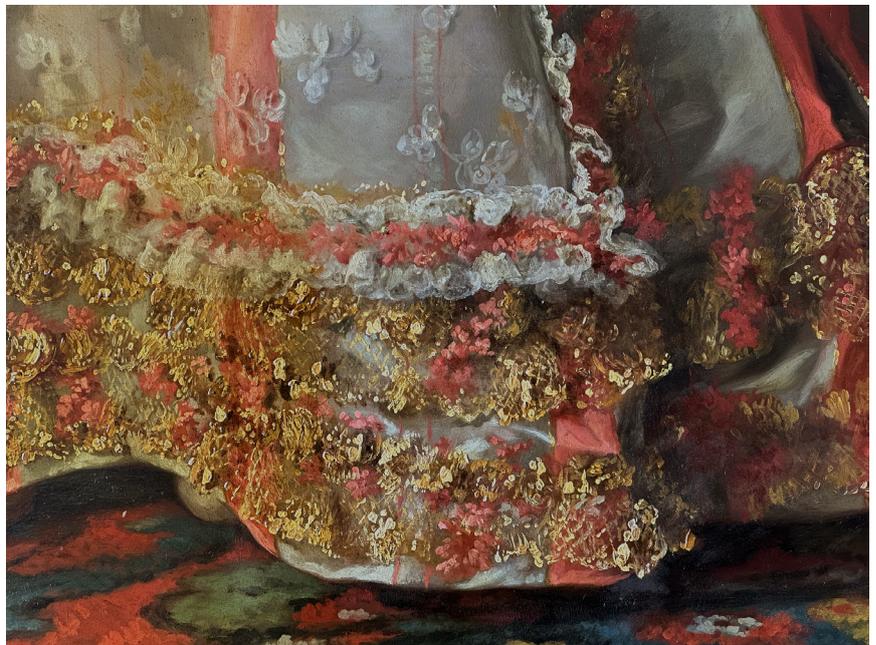
The painting showed dirty, yellowed and blanching varnish coatings as well as darkened retouching (cf. *figs. 5a, b*). The original paint layer is noticeably well preserved, which is rare for paintings of this date. In the past rigid framing and worse climate conditions caused stress to the sensitive panel. This, together with mechanical damages and small paint losses, lead to a restoration process in 2023.

Figs. 5a, b
Details during restoration; the paint layer of the dress is noticeably textured. The open brushstroke conveys the vivid fluffy quality of the dress and glossed highlights create a three-dimensional impression of the laces of the dress and of the brooch.

The measures included thinning the layers of yellowed varnish, removing old retouching, gluing recent cracks and integrating paint losses. This not only brought out the full intensity of the painting's brilliant colours, but also generally stabilised the wooden panel and achieved a cohesive appearance. In addition, the painting was enclosed in a climate-controlled display case integrated into the frame to protect it from climate fluctuations.
